Multiple-Purpose Project  
Marmaton River, Kansas

### Historical and Architectural Field Survey of a Portion of Fort Scott Lake Project, Bourbon County, Kansas

Environment Consultants, Inc.

1989

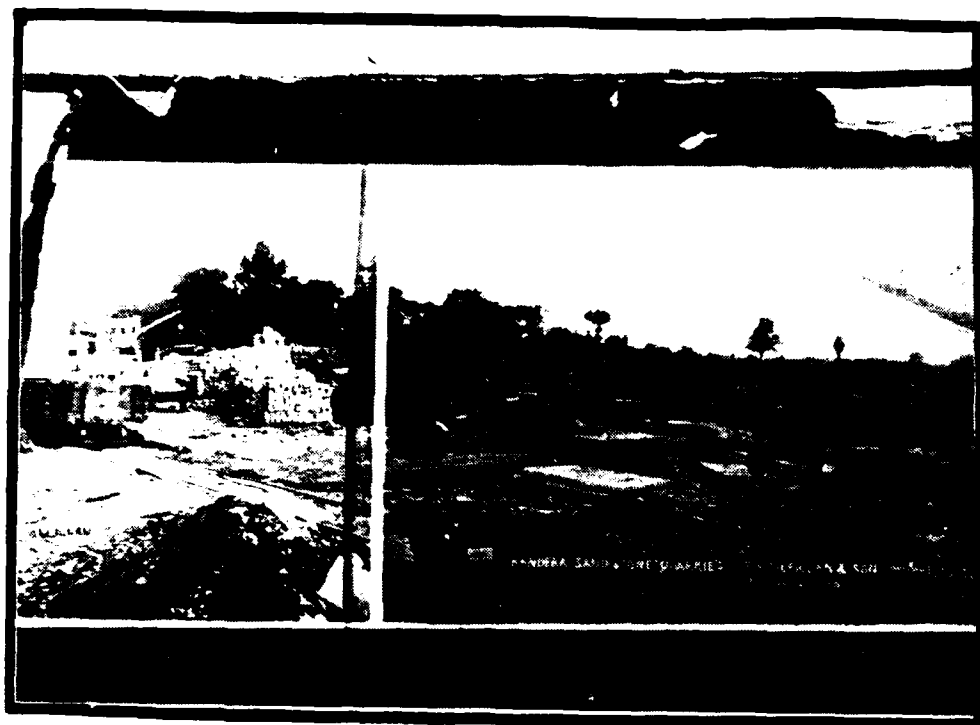
Figure 5. View of Bandera Quarry captioned "Bandera Flagstone Quarry, R.S. Gilfillan & Son, Prop." Photograph from the family collection of Mrs. Anita Gilfillan Stine.

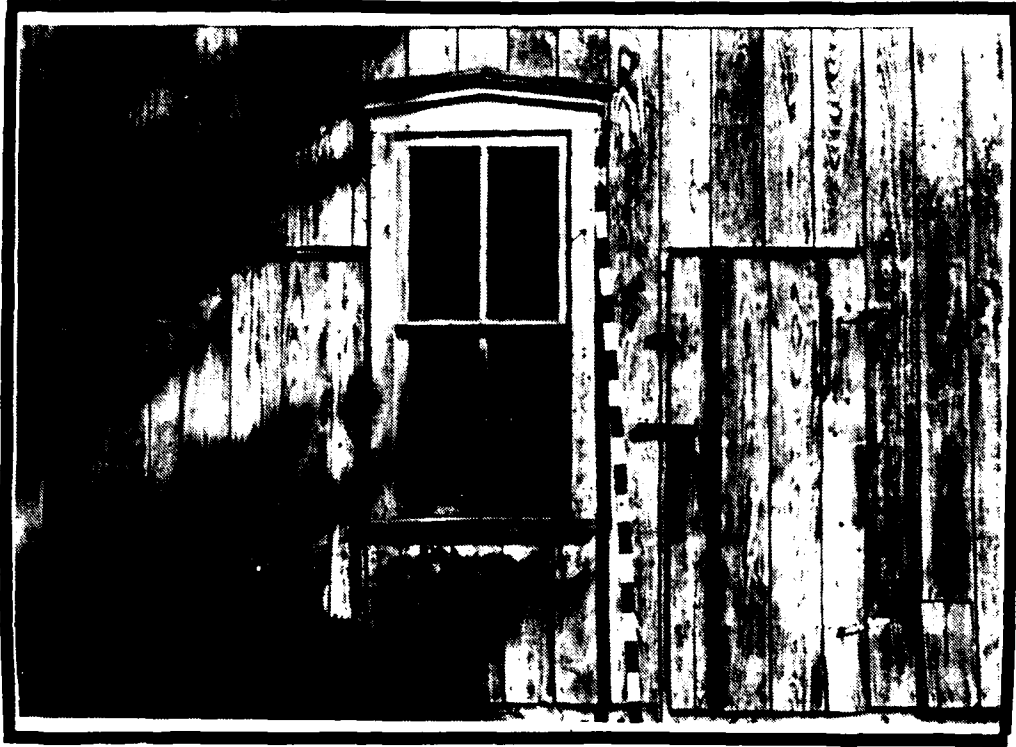
Figure 10. Greek Revival window typical of windows of this period in the project area. This window is in the barn on site FN24.

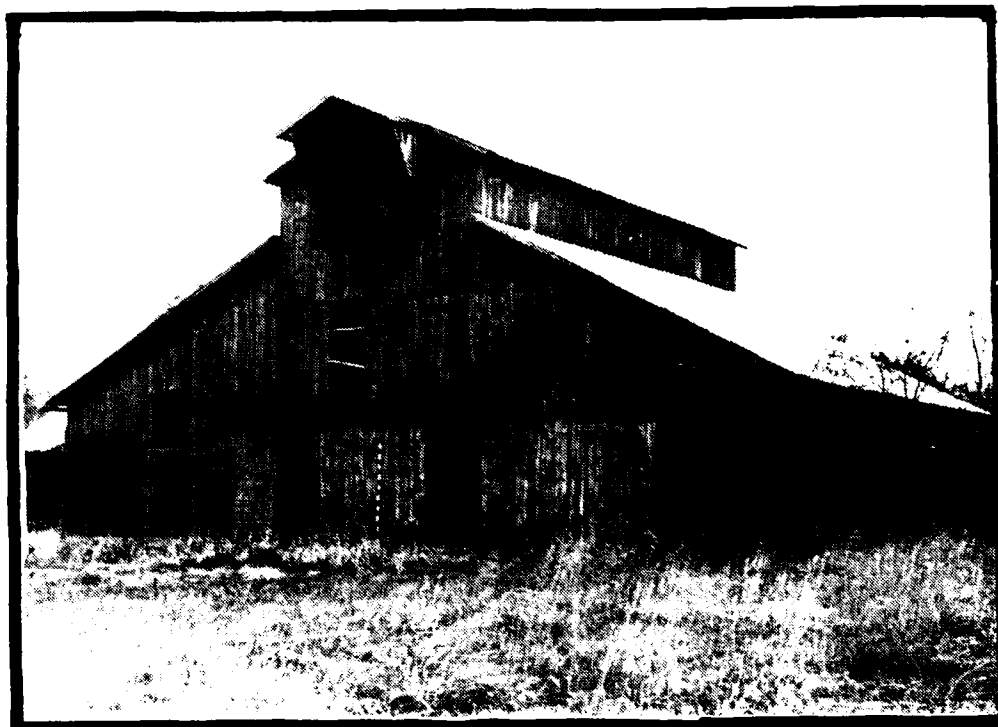
Figure 19. East elevation of barn at FN8 looking southwest. Monitor barn with an enclosed square-shaped hay hood.

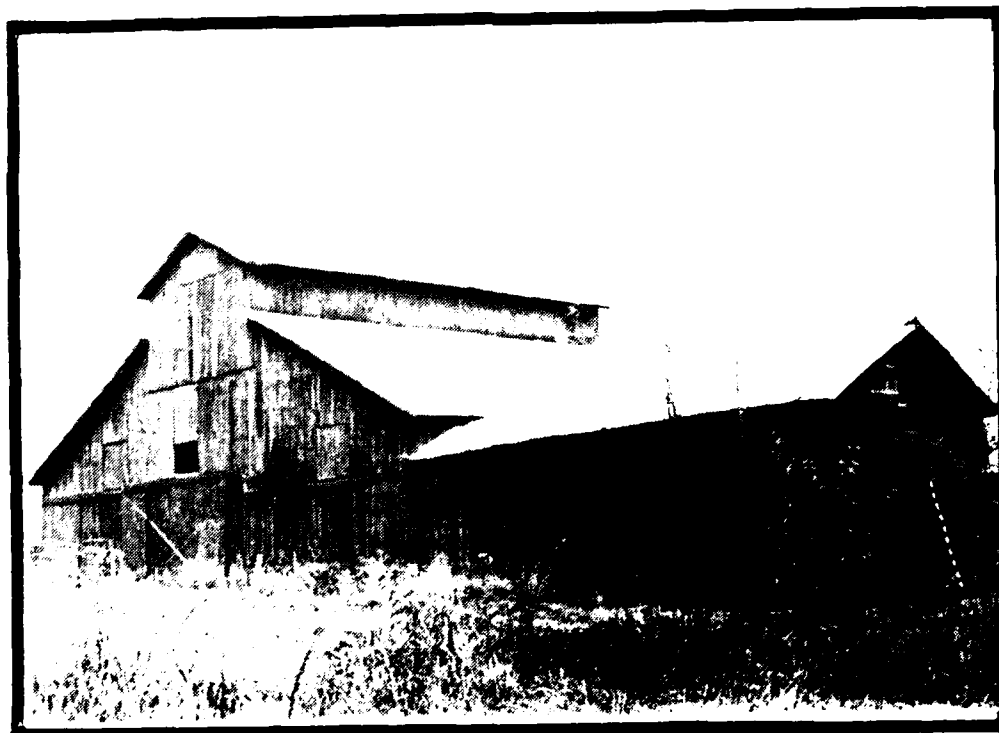
Figure 20. West elevation of barn at FN8 looking northeast. Monitor barn showing the rectangular extension of the southeast corner.

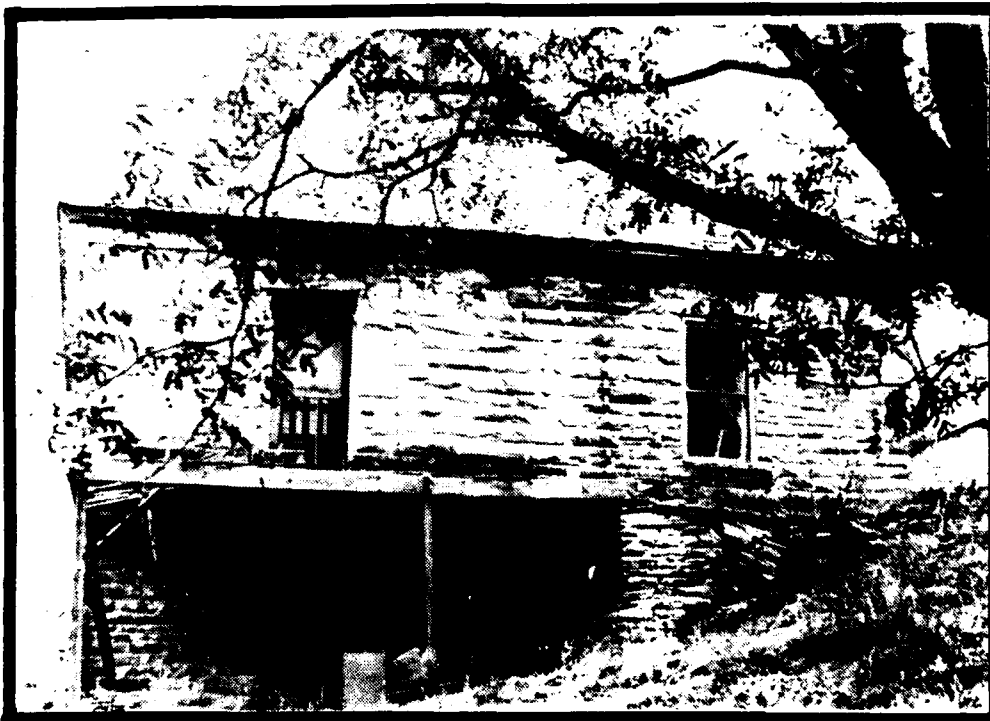
Figure 24. East elevation of house at FN10 looking west northwest. Remains of porch on east side.

the original wood shingles and brick chimney flue. There used to be a two-story wood porch on the east side, but only parts of the porch flooring remain. A red brick corbelled chimney flue rises out of the center of the roof. The eaves are boxed. Only one alteration has been made, to the northwest corner of the house. The addition appears to have been an open porch that was later closed in. The root cellar is adjacent to the east end of the house and is banked also.

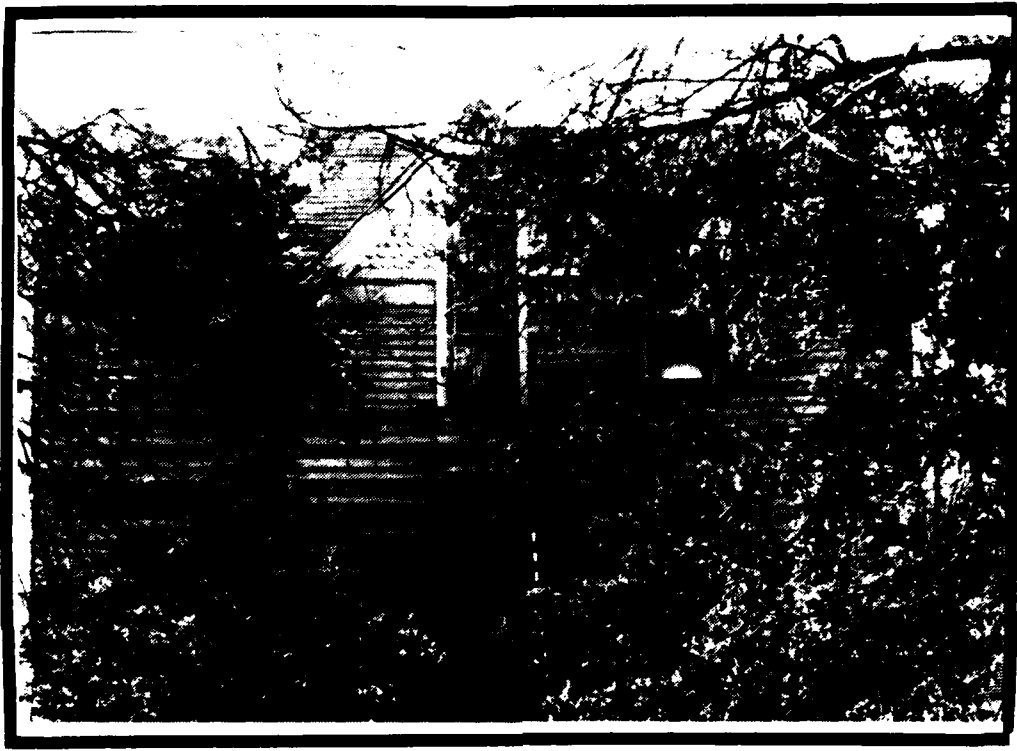
Figure 27. North elevation of house at FN12 looking south. Two-story hall and parlor house showing window and door details and fish scale gable detailing.

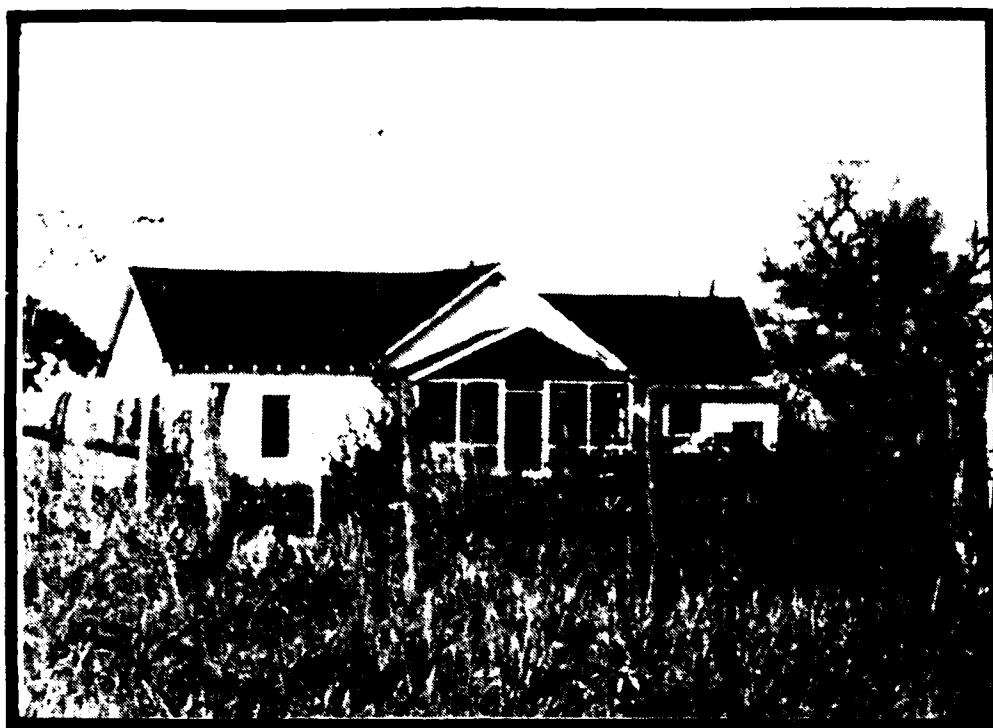
This site was included in the windshield survey but does not meet the 50-year National Register age requirement. The house is a planbook style (Figure 28).

Figure 28. South elevation of house at FN13 looking north northeast. Planbook house typical of 1940s style.

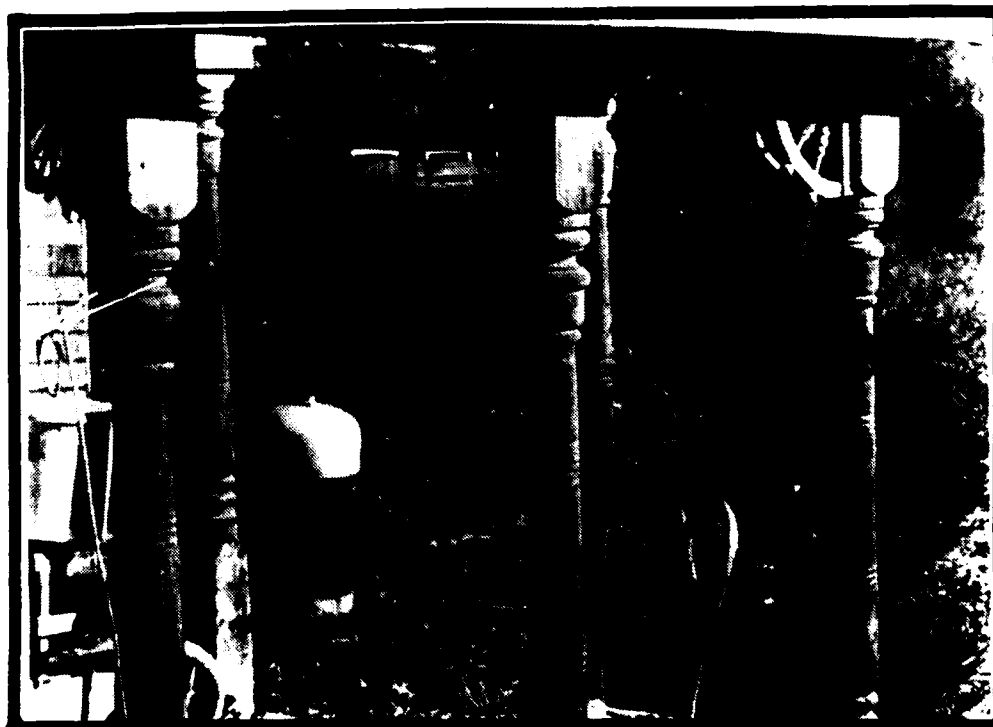
Figure 29. Southeast corner of porch on house at FN14 looking northeast. Detailing of turned porch posts on the porch at the southeast corner of the house.

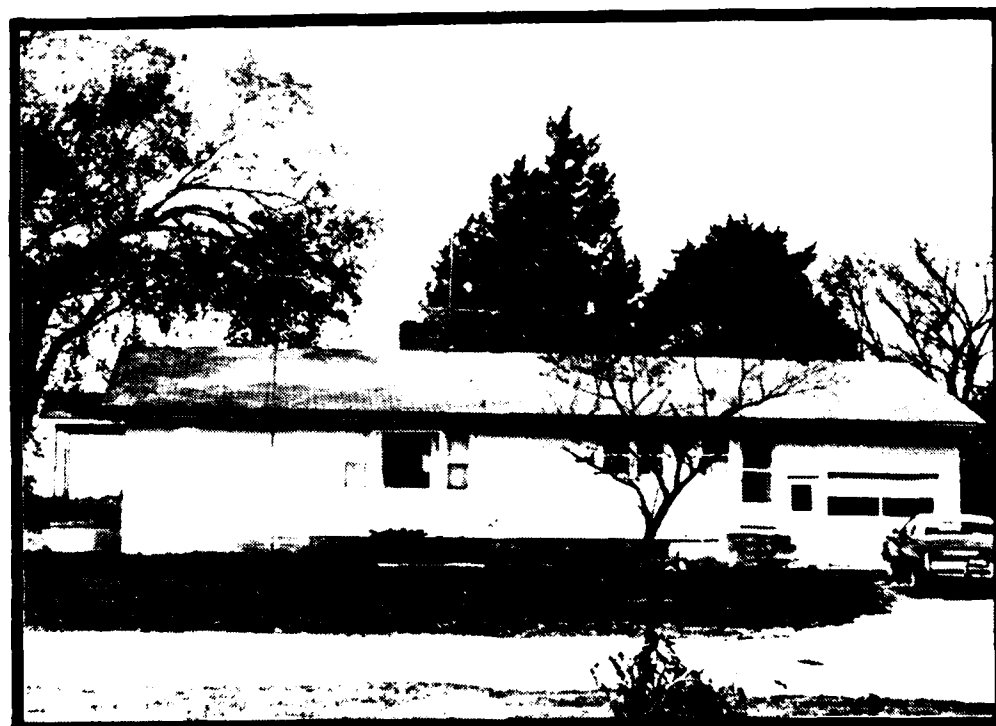
Figure 31. East elevation of house at FN16 looking west. Modern farmhouse with 9-in aluminum siding.

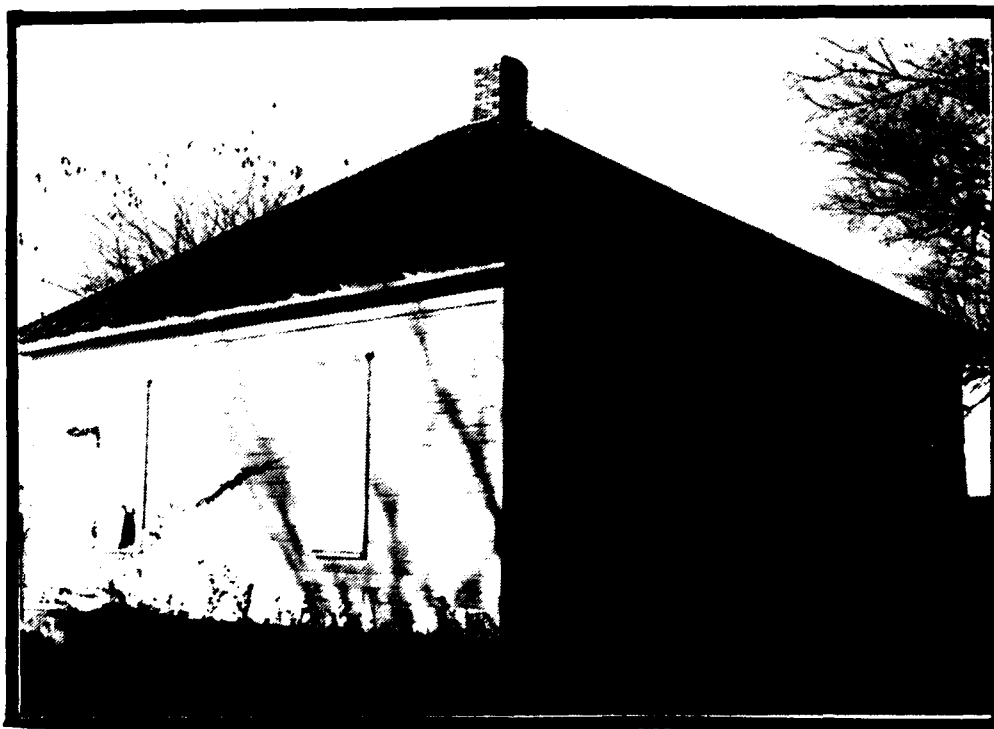
Figure 35. North and west elevations of house at FN19 looking southeast. Four-room square house with central brick chimney flue.

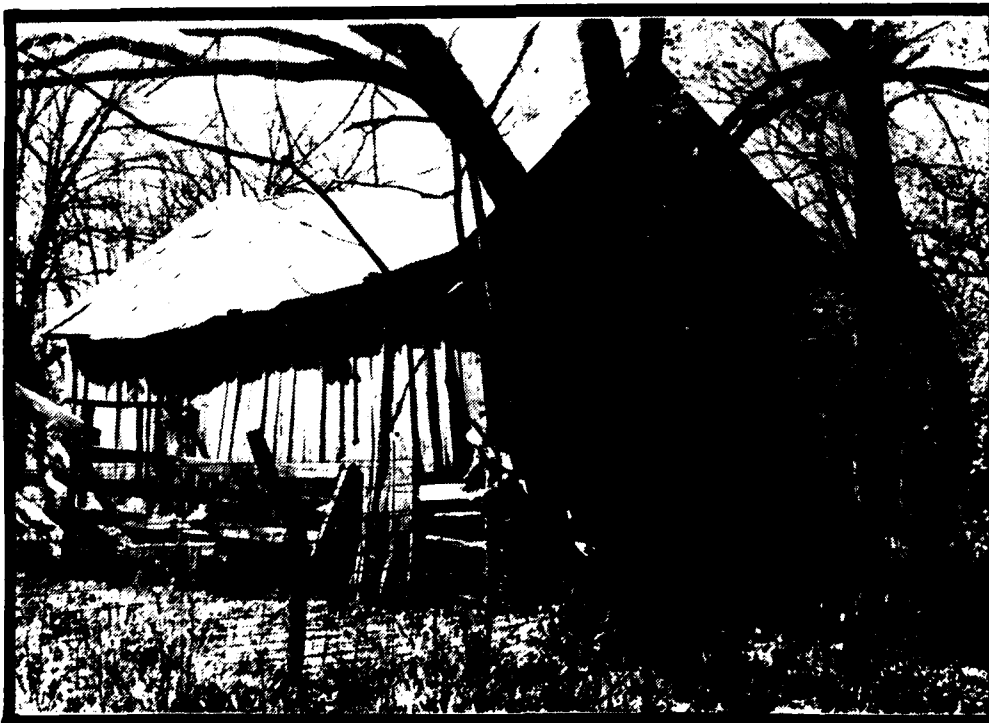
Figure 37. East and south elevations of barn at FN21 looking southwest. Board and batten barn with corrugated tin roof.

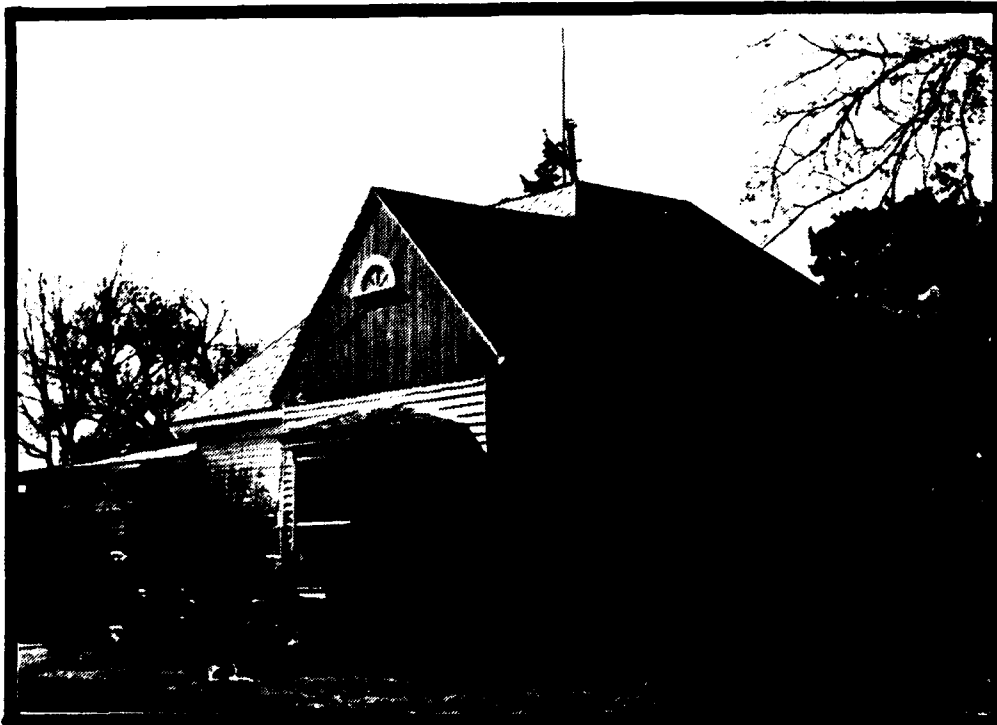
Figure 39. North elevation of house at FN23 looking southwest. Planbook house with bay window on end gable.

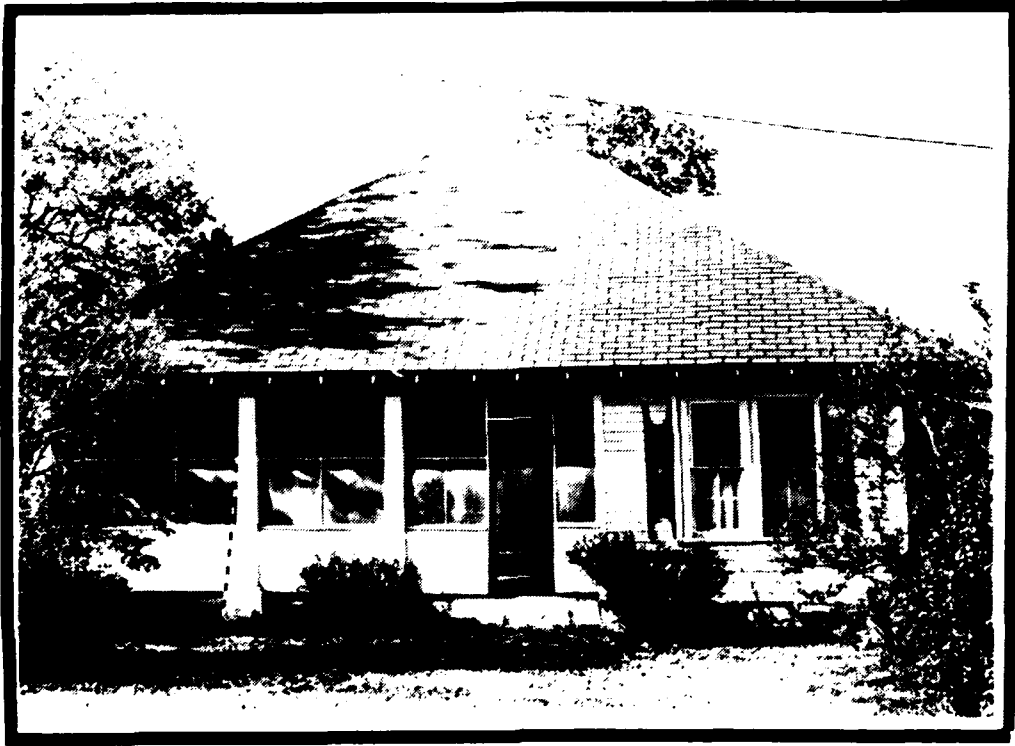
Figure 40. East elevation of house at FN24 looking west. Planbook house with cut-out screened-in porch.

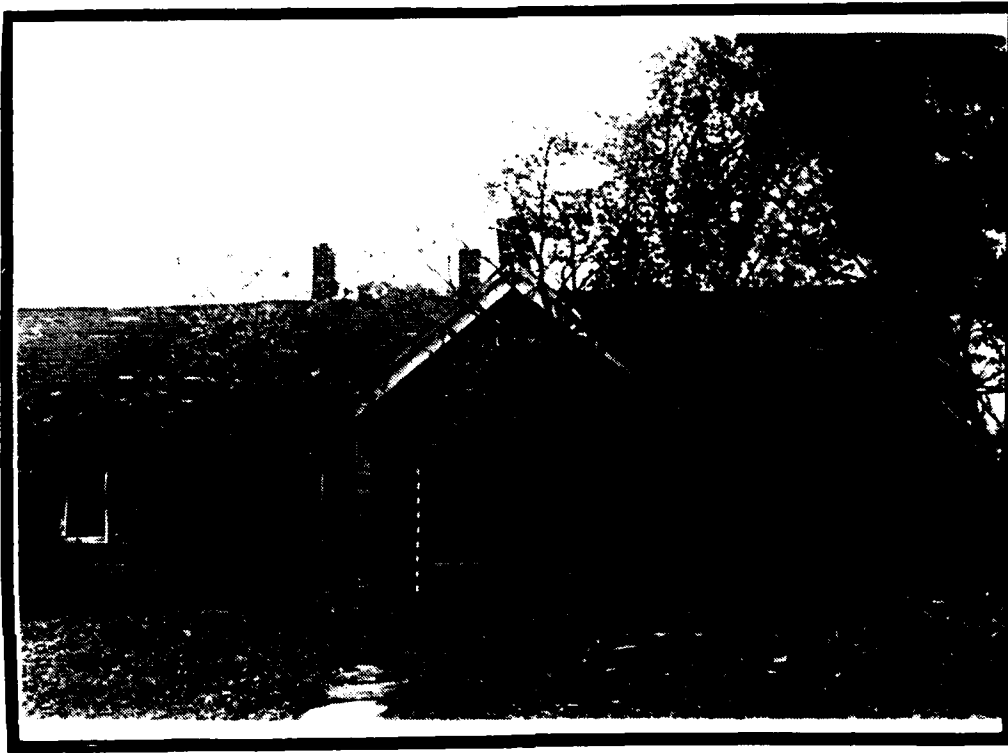
Figure 41. North elevation of house at FN25 looking south-southeast. Second-story elevation of a banked house showing wall, roof, window and door details.

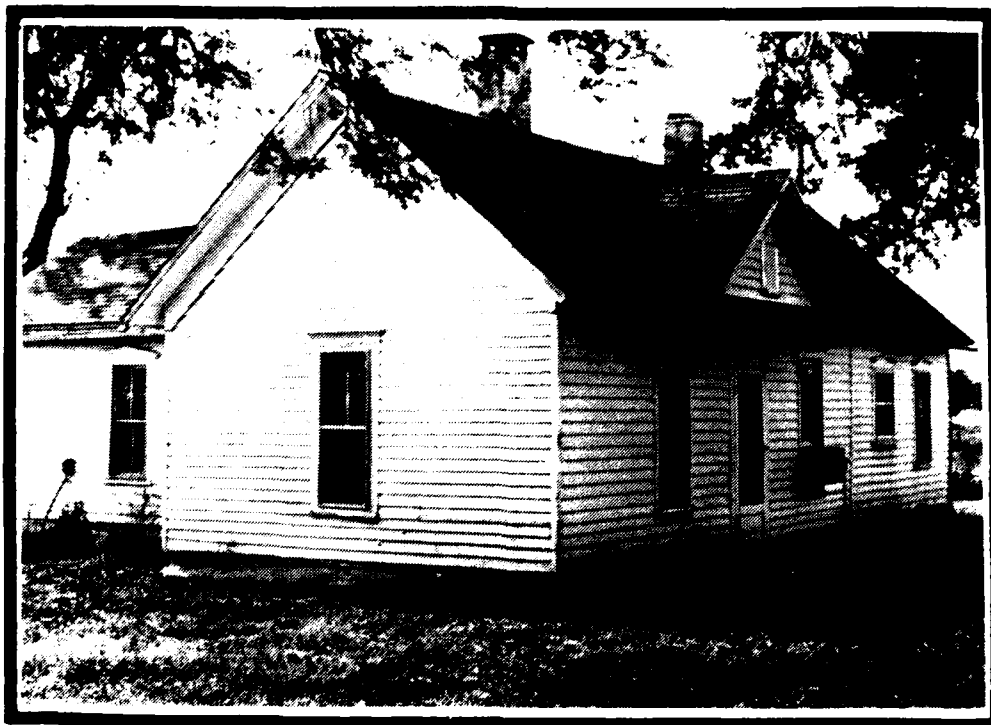
Figure 47. North and east elevations of house at FN29 looking southwest. One and one-half story T-house showing chimney locations and door and window trim details.

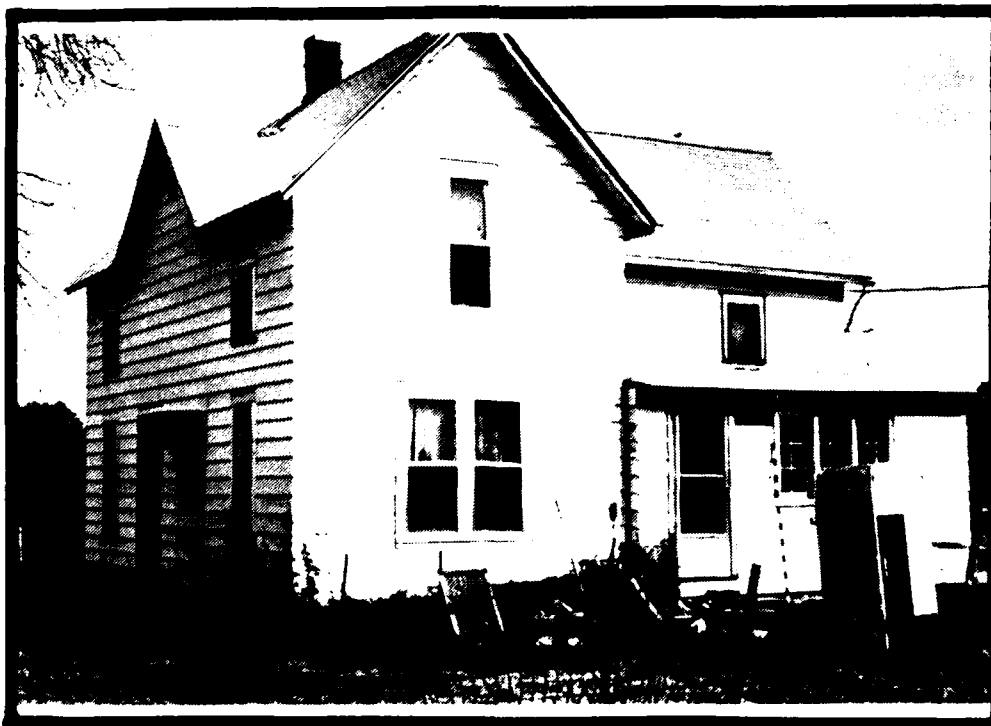
Figure 48. South elevation of house at FN36 looking northeast. Two-story T-house with a small closed-in porch addition.

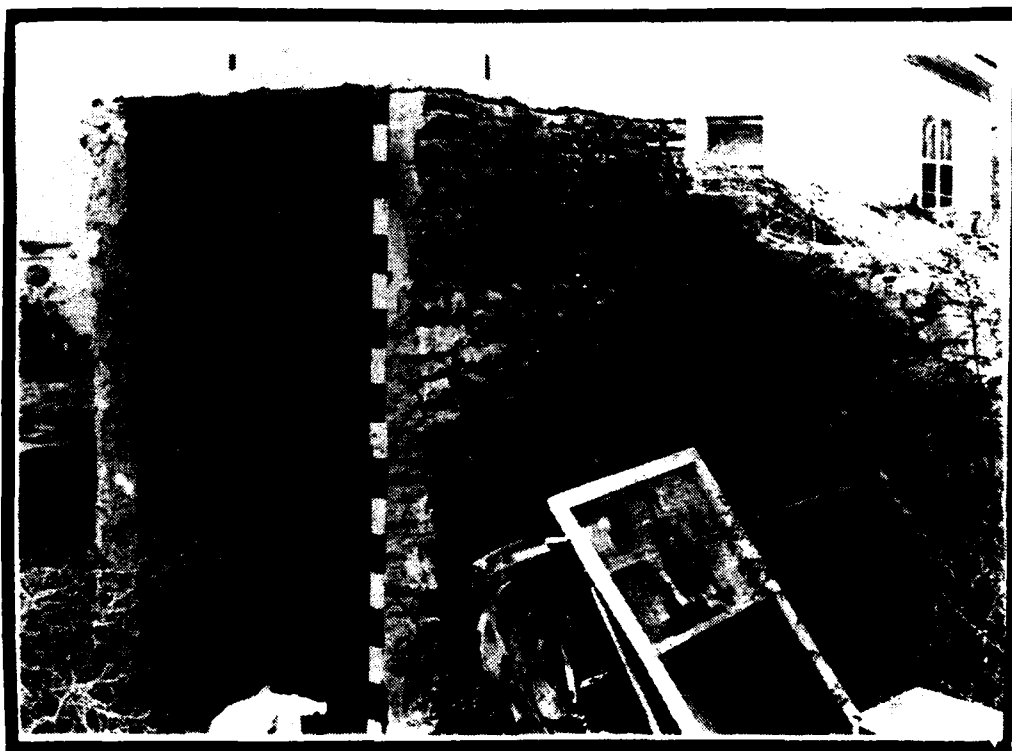
Figure 49. Detail of cellar entrance, looking southwest.

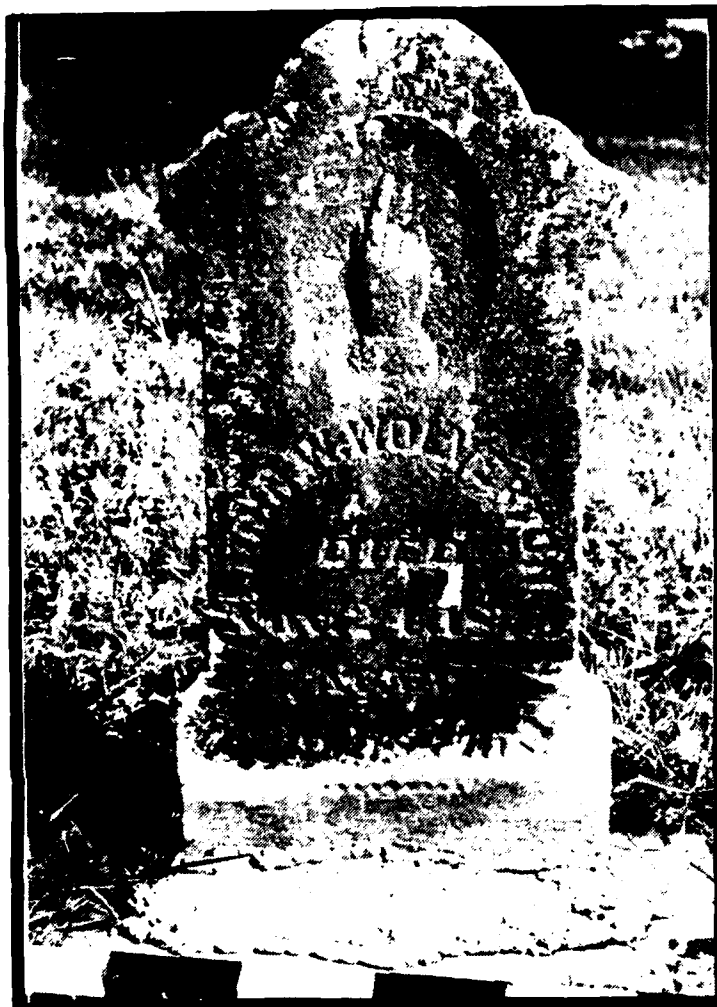
Figure 52. West face of gravestone at FN31 looking east. Multiple-curve tombstone in the Pleasant Valley Cemetery.

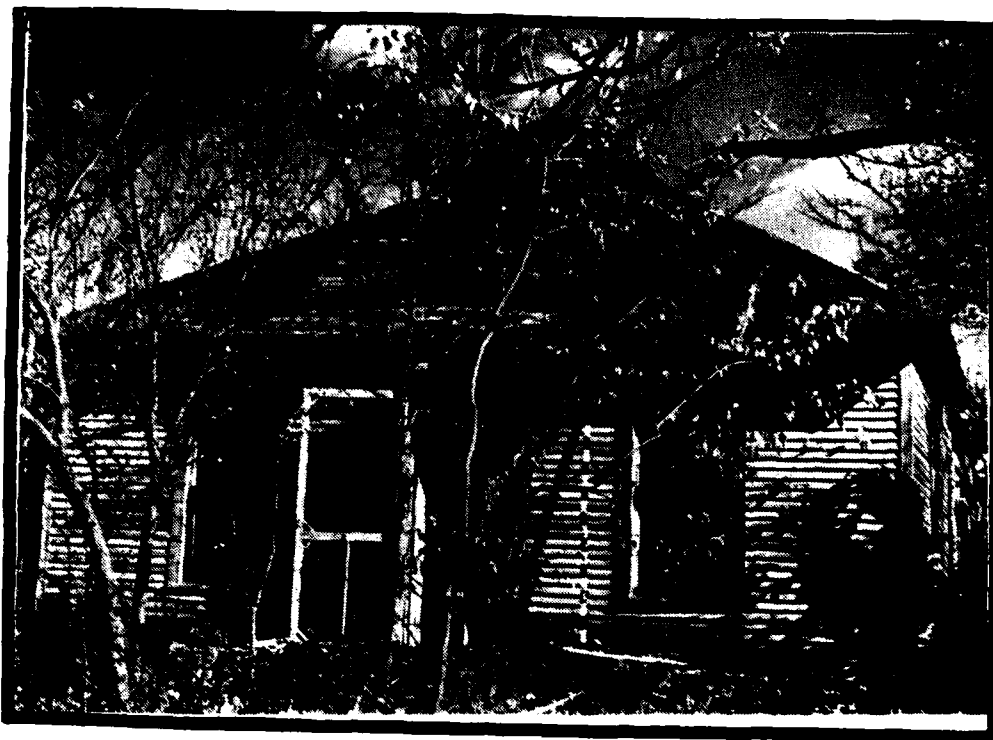
This site consists of a house and barn. The house is cubical with a truncated pyramidal roof (Figure 55). The door and window lintels are Greek Revival. The windows are one-over-one sash. The house is sided with weatherboard and the roof has asphalt shingles. The eaves are open and roof rafters are exposed. The barn is badly deteriorated and has been renovated so many times the original structure is undiscernable.

Figure 55. West elevation of house at FN35 looking east. Four-room square-shaped house with a shed-roofed dormer.

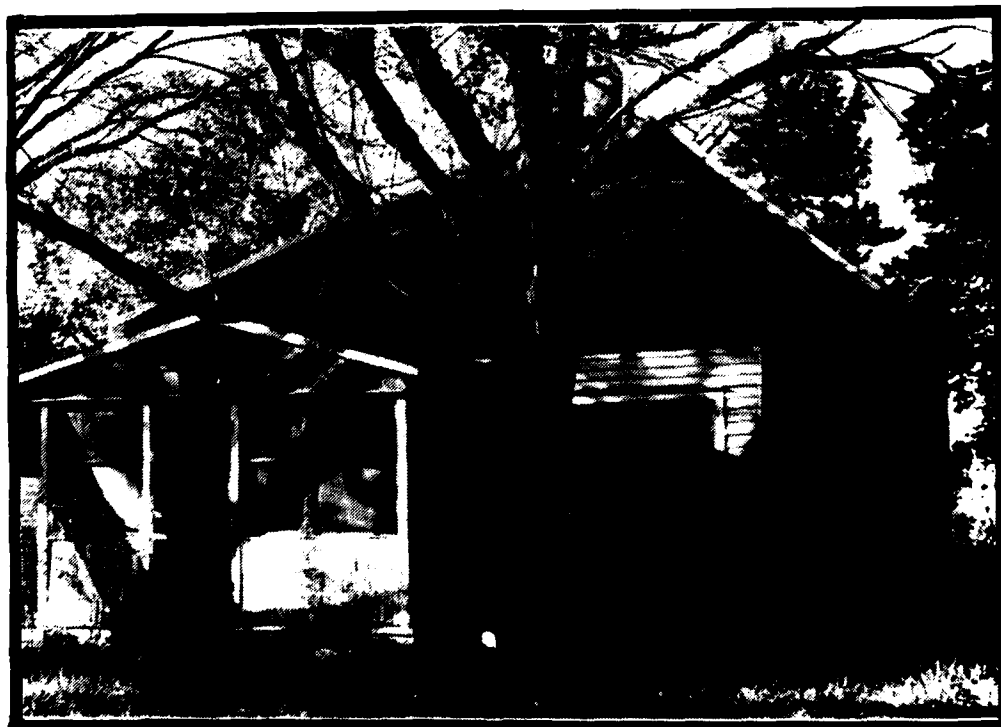
This site includes a house, a barn, and a garage. The four-room house is roughly square in plan, with a corner door (Figure 58). The well is covered by a wooden lattice gazebo. The barn has a square-shaped hay hood with brackets, and the north wall of the barn is coursed unmortared limestone.

Figure 58. South elevation of house at FN40 looking northwest. Pyramidal-roofed planbook house with corner door entrance.

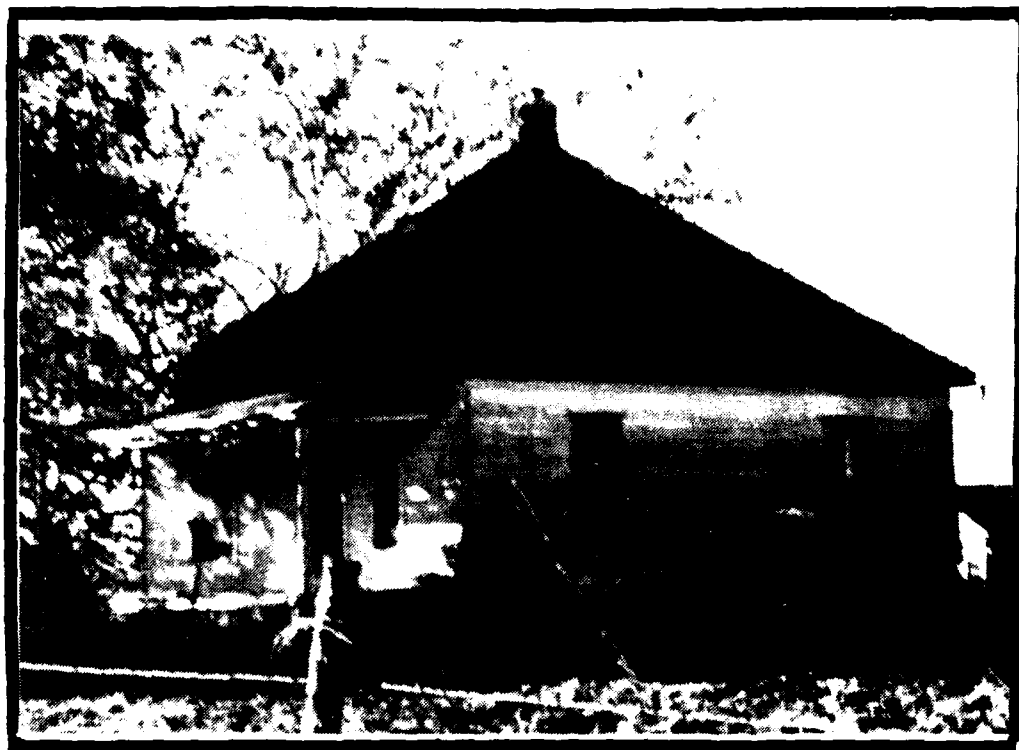
This site includes a four-room house roughly square in plan, with one front door (Figure 59). There is a rock fence on one side of the house.

Figure 59. East elevation of house at FN41 looking northwest. Four-room square-shaped house with center chimney flue and pyramidal roof with wooden shingles.

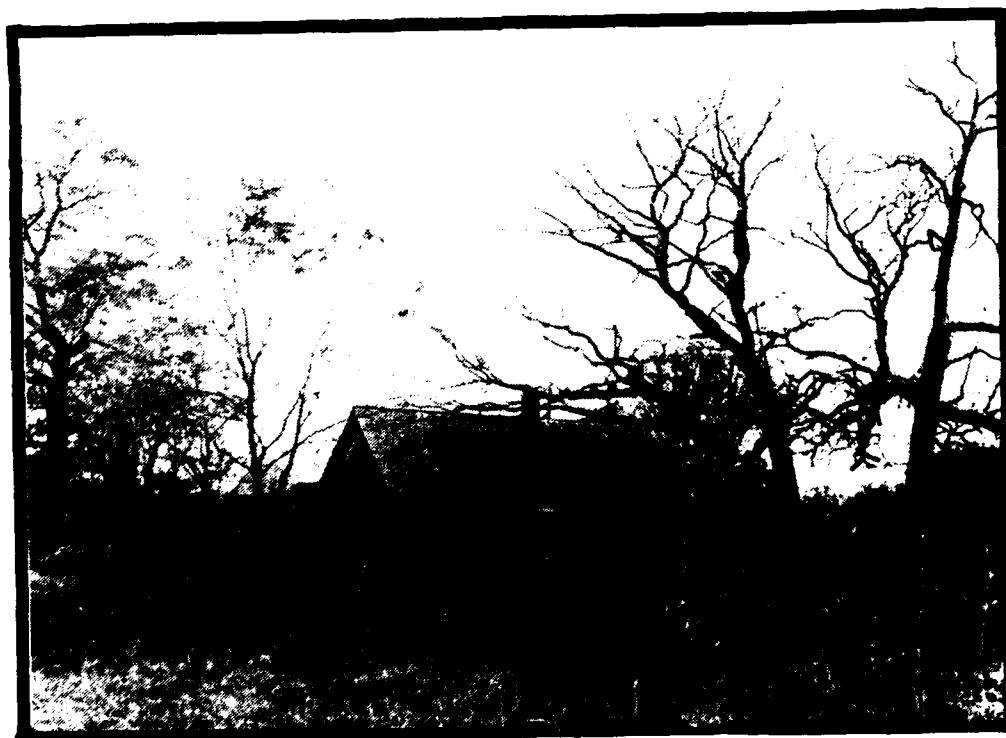
Figure 65. East elevation of house at FN50 looking west. Two-room house with center chimney.

This site includes a one-story, two-room house with a central chimney (Figure 65).

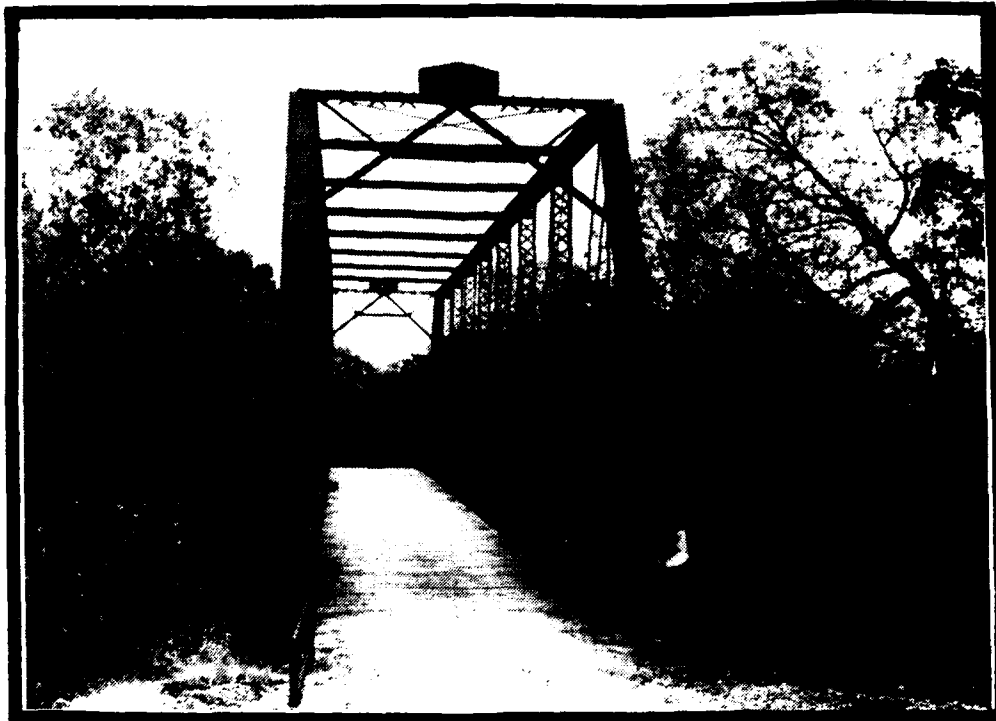
This site consists of a one-lane iron Pratt half-hip bridge, manufactured by the Canton Bridge Company, Canton, Ohio (Figure 66).

Figure 66. FN51 looking north. Pratt half-hip bridge constructed ca. 1900 by the Canton Bridge Co., Canton, Ohio.

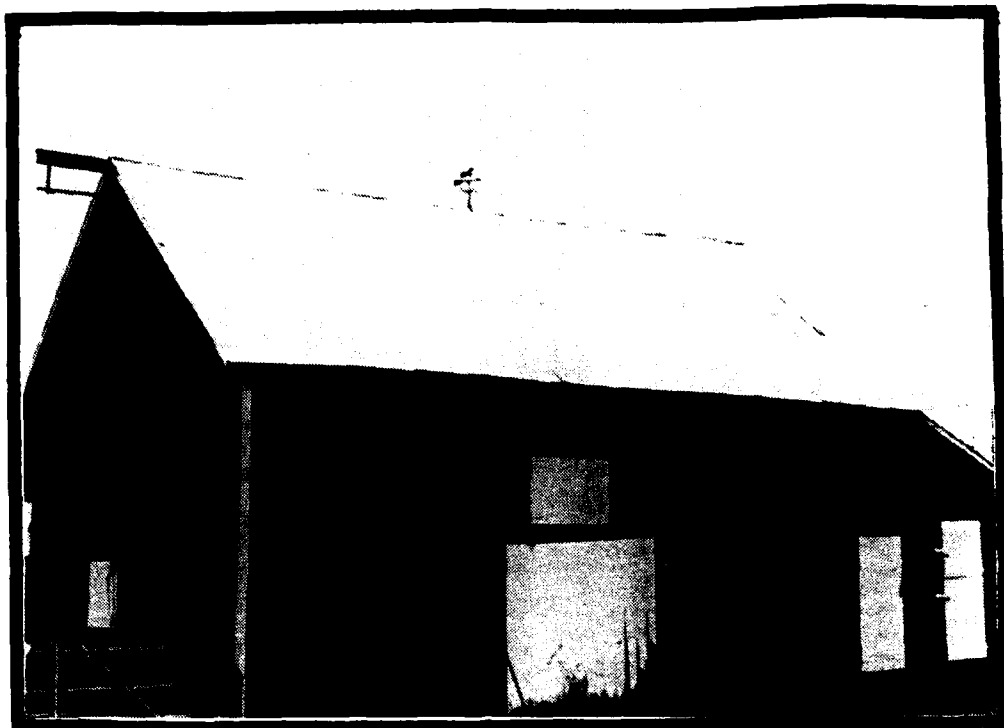
This site includes an English barn sided with board and batten (Figure 68), and a one-story house.

Figure 68. West elevation of FN 54 looking east. Red barn with white trim.

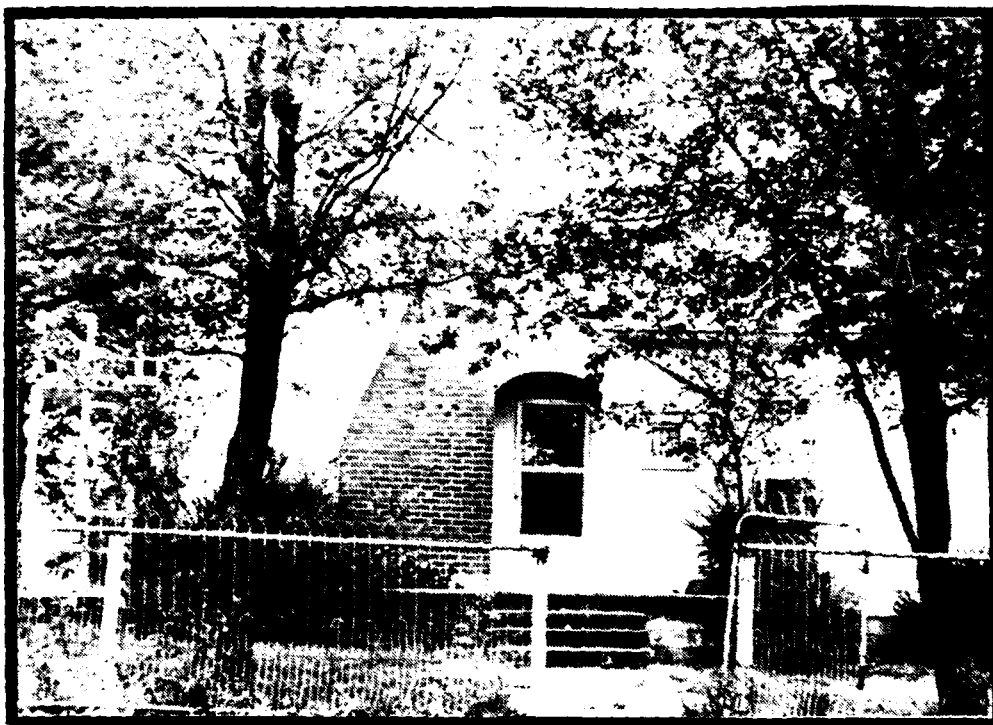
This site includes a vernacular Elizabethan Revival, two-story house with an exterior wall chimney (Figure 70). The barn has a gambrel roof with lean-tos on either side of the main barn unit.

Figure 70. North elevation of house at FN56 looking southeast. Detail showing Elizabethan Revival porch and the exterior chimney box and flue.

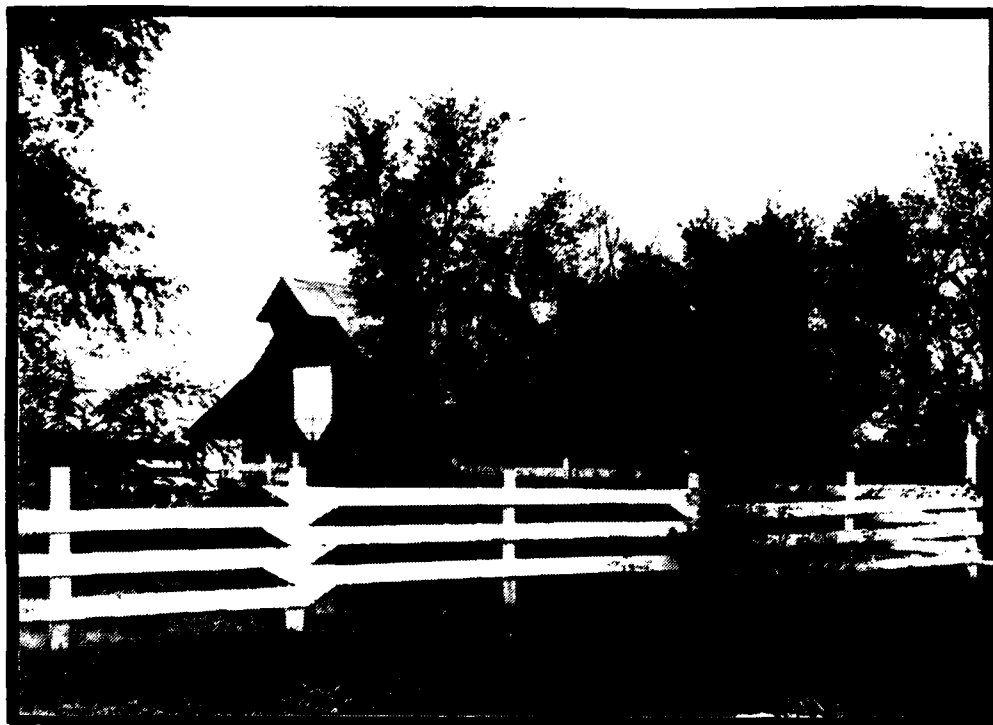
This site was not in the project area. A photograph of the barn was included in the survey information because it was a well-kept example of a typical barn type in the project area (Figure 72).

Figure 72. East elevation of barn at FN58 looking southwest. Barn with square-shaped hay hood.

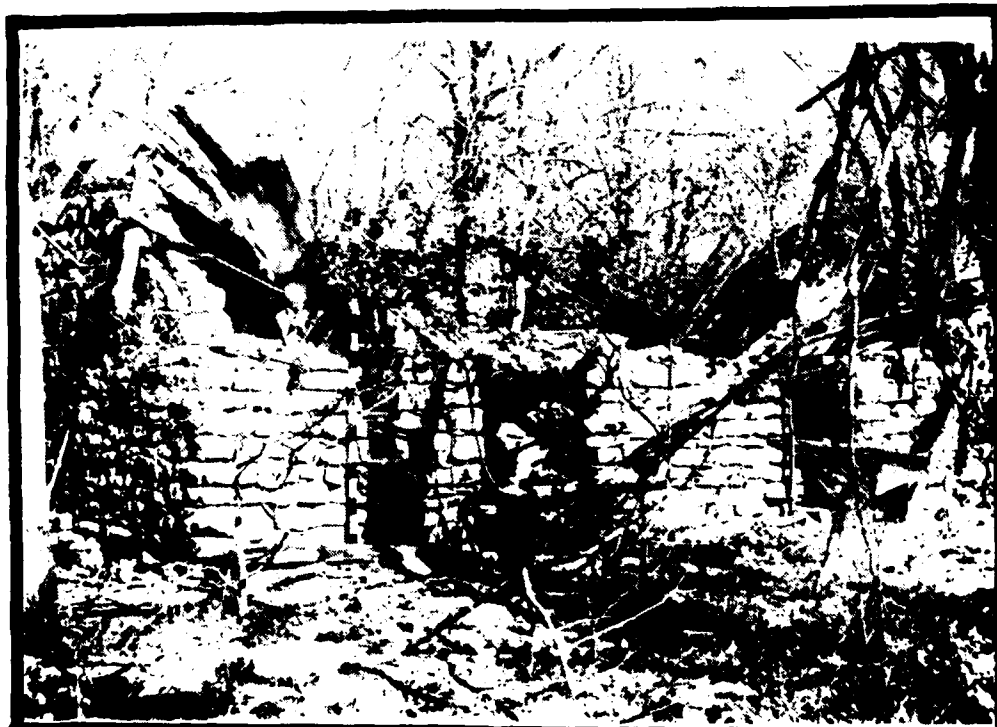
Figure 76. South elevation of house at FN66 looking north. Deteriorated stone house.

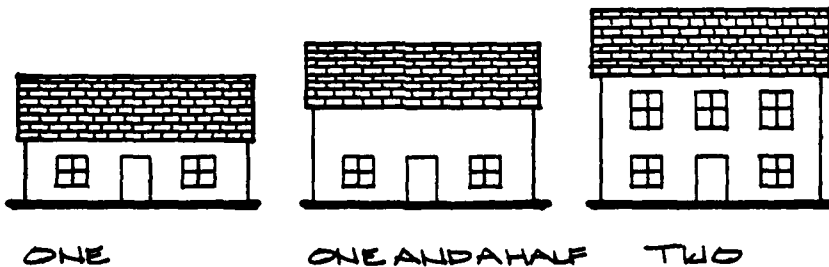
### STORY HEIGHT

STORY HEIGHT IS DEFINED BY COUNTING FROM THE GROUND UP.

ONE

ONE AND A HALF

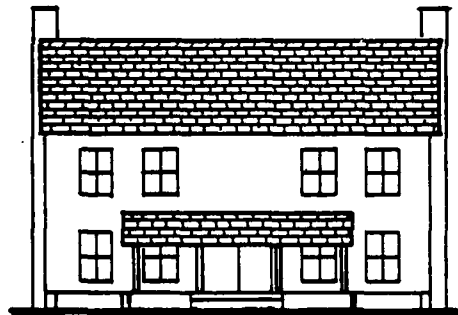
Figure 102.

- ALWAYS TWO-STORY
- PORCHES VARY
- MAIN ROOF IS GABLE
- NO TRIM
- FINISHING MATERIALS CAN VARY

Characteristics and features of the I-house folk house type (from Baird and Shaddox 1981).
